# The James Weldon Johnson Foundation 2022 Report

# IN PROCESS IMAGES

## JAMES WELDON JOHNSON WRITING CABIN

**December 29, 2022**

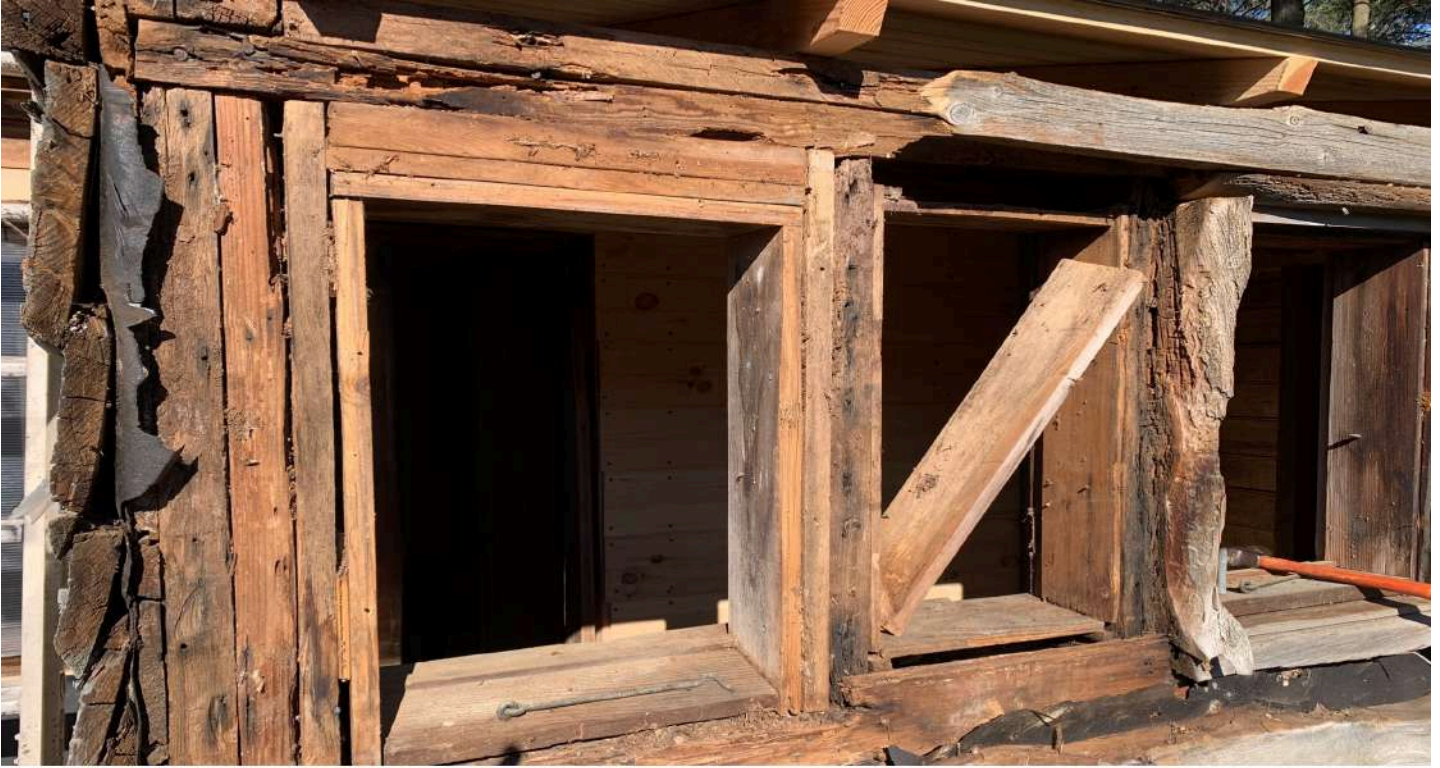
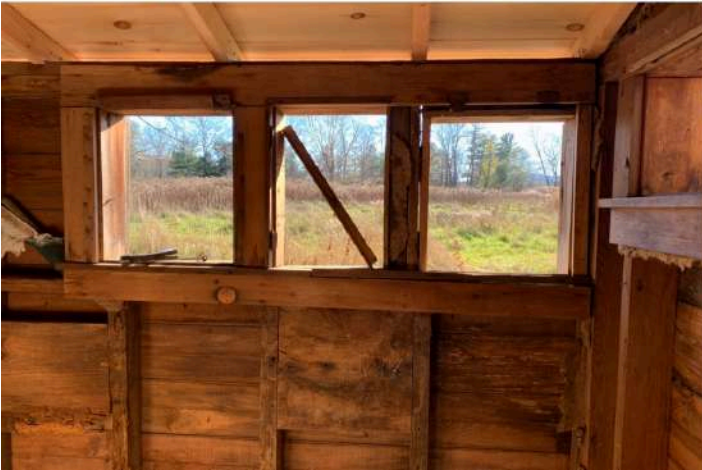
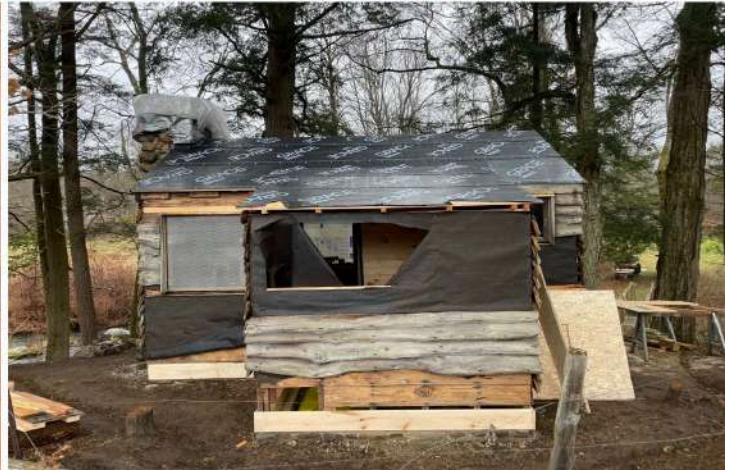
## WRITING CABIN - SOUTH EXTERIOR

## Recreation/installation of missing window sash

The windows will all be either restored or recreated to match, depending on the condition of each individual window. The small square awning windows have sash that are mostly intact and can be used as the pattern for millwork profiles. The awning sash are in poor condition but have enough material remaining to provide profile information. The larger double casements that show in historic photos are gone, but the photos show the muntin divisions, the hinging and other details. The window frames and trim themselves are mostly in good condition apart from maintenance and small repairs. The window sash will be restored and recreated in a specialty shop devoted to that purpose. Since the cabin was not heated and will not be heated apart from the small fireplace, the sash is single glazed and will remain as such. It remains possible to install storm sash, although none show in the early photos of the cabin. Metal fittings and hinges will match as nearly as possible the ones that can be seen either inside or in the photos. The built-in roller shades will be restored.

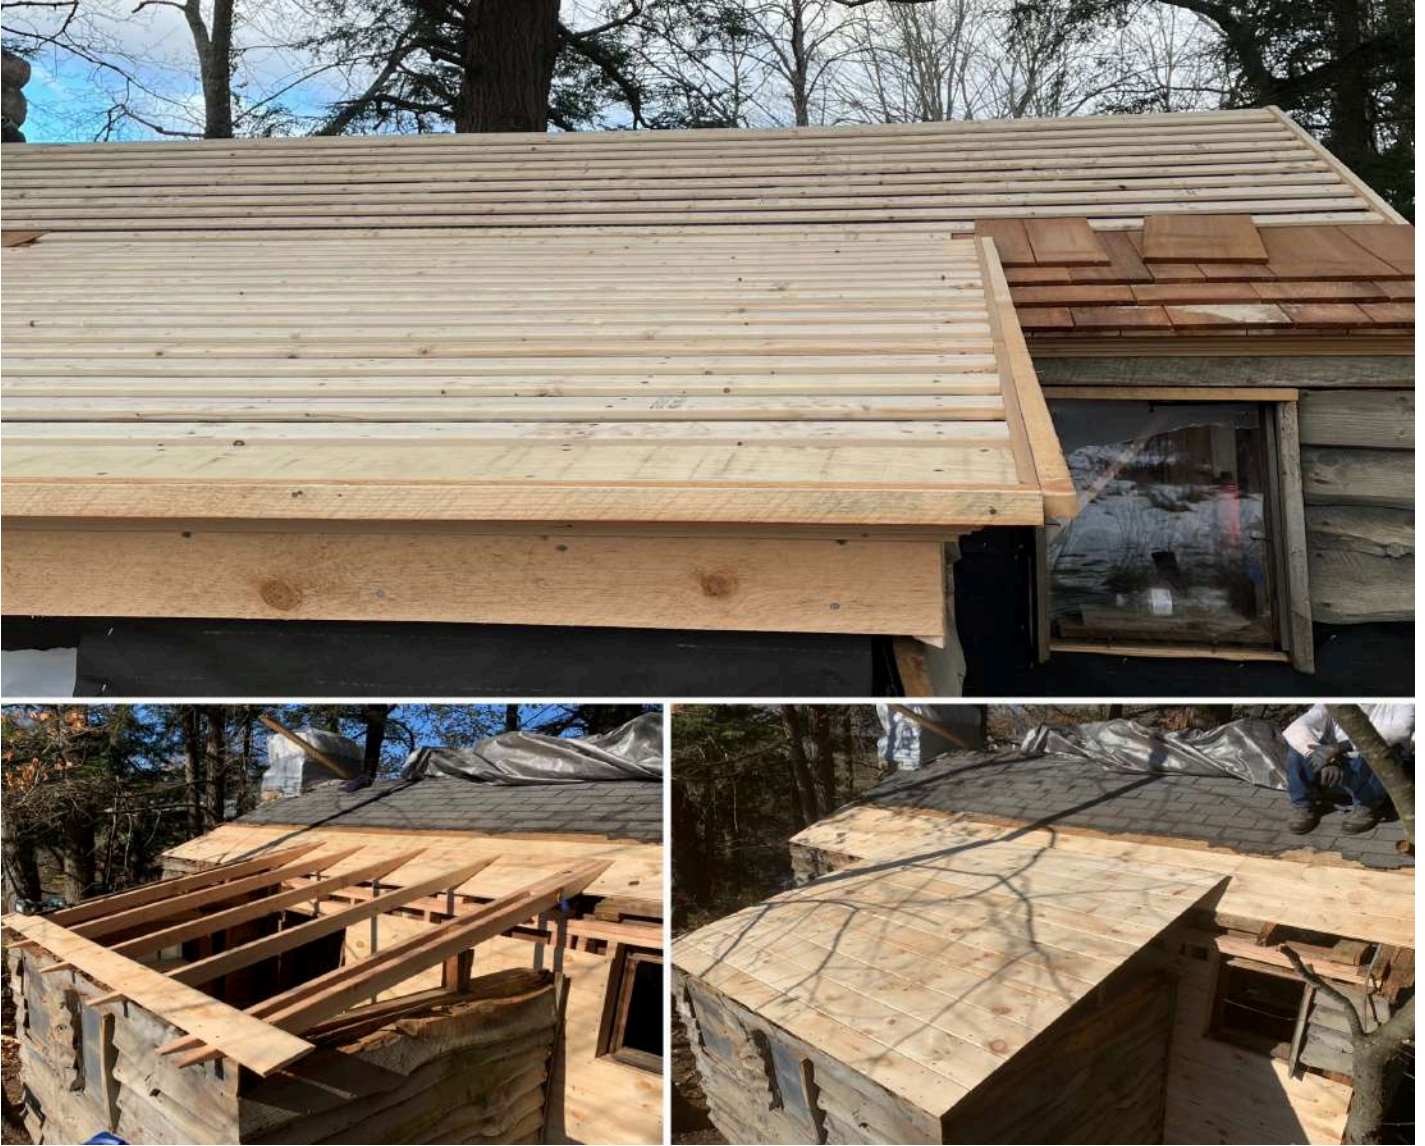
### WRITING CABIN - UPPER VIEW

## Replacement of cedar shake roof and leaded copper flashing

The original roof was cedar shakes on closely spaced wooden board sheathing on top of tongue-and-groove beaded board, with the beaded board fastened from above to the rafters and running at 90 degrees to the rafters. No roofing nails penetrated the beaded board when constructed. The roof is restored using a two-way ventilating wood grid on top of building paper ("tarpaper") laid over the beaded board, with the lower members parallel to the rafters, directly on top of them and secured through the beaded board to them. On top of those new strips, which run from the eaves to the ridge, a second set of strips at 90 degrees are placed, to serve as spaced board sheathing for the new cedar shakes. The shakes are nailed to these spaced boards. A continuous ventilation slot running along the eaves just below the shakes are formed by holding the eaves trim below the bottom of the overhanging shakes approximately 1/2 inch. The slot is continuously screened to keep insects and vermin out. A continuous ridge vent allows the roofs to vent at the highest point of the roof. The 15-lb. building paper will provide protection of the beaded board from any leaks in the shakes, as will the ventilation grid below the shakes.

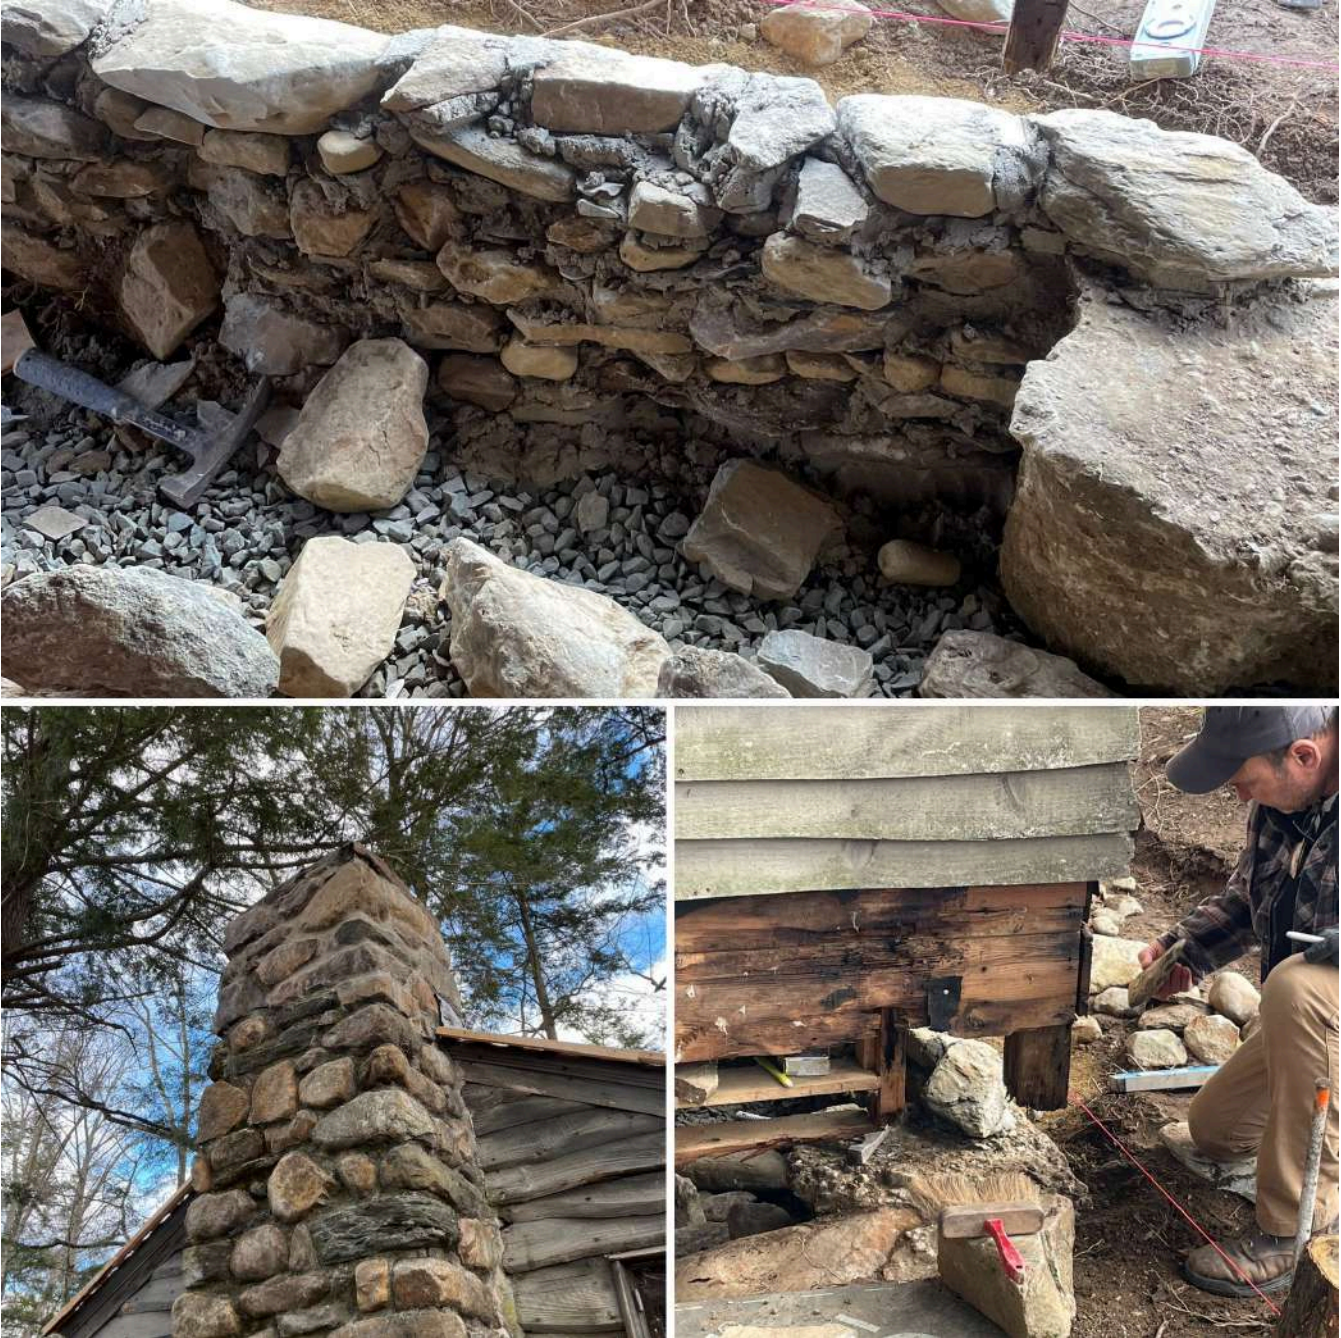
### WRITING CABIN - FOUNDATION AND CHIMNEY

## Fieldstone foundation and chimney masonry repairs

The fieldstone foundation and chimney are in generally good condition and required repair in places. The original stones were mostly where they fell and have been collected for reuse. They are reset using a mortar like 1 part Type I or II Portland cement: 2 parts hydrated lime: 8 to 9 parts bulked sand, with small quartzite inclusions to match various areas of the existing. Weakened joints were deeply scraped and repointed. The introduction of small amounts of Portland cement into masonry mortar was underway at the time of the cabin's construction and may explain why the masonry is still in relatively sound condition.

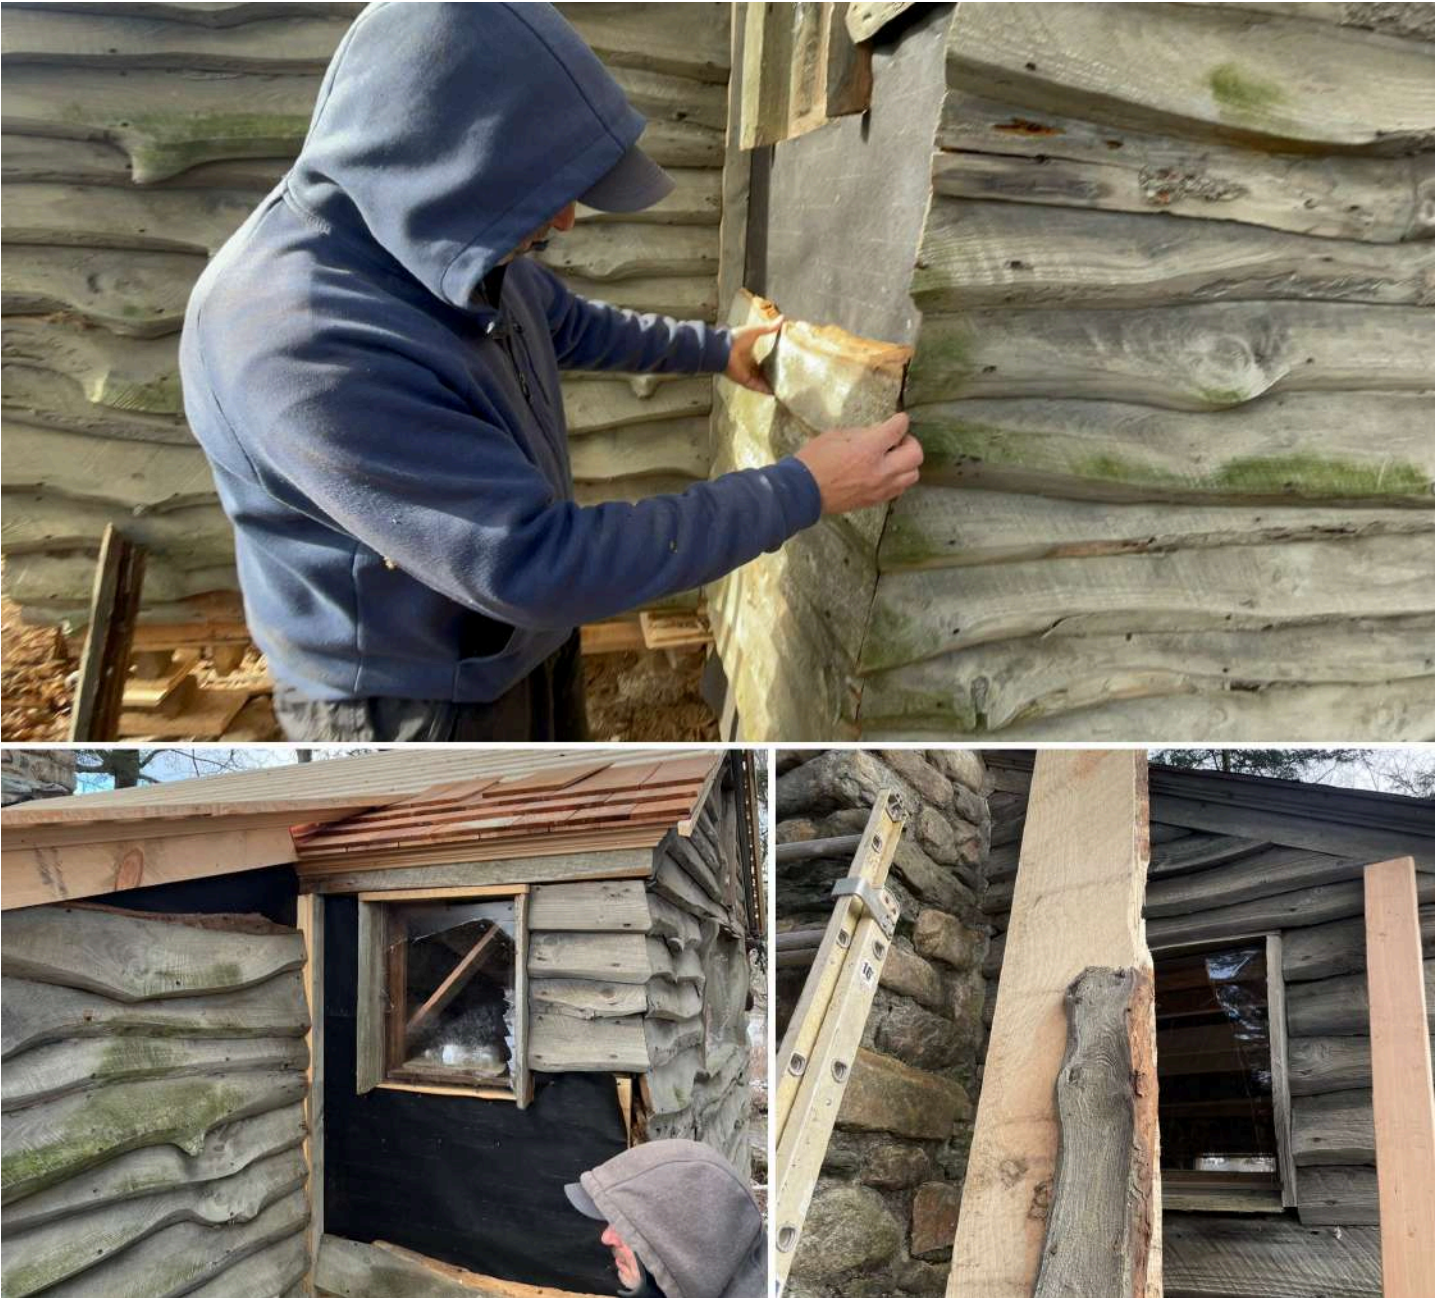
### WRITING CABIN - WOODEN SLAB SIDING

## Repairs to wooden slab siding and trim; staining

The wood slab siding is mostly intact, as is the trim, but has areas needing repair. The species is believed to be white cedar, and has been matched for repairs. It has held up extremely well, in part because the amount of direct sun on the cabin was limited by tall well-spaced surrounding evergreens. Yet the trees did not create an overly moist environment either, which would tend to compromise the building's outer services with moss and discoloration due to mildew and fungus. Most damage that has occurred to the siding has been either a result of proximity to grade or invasion by pests such as bees and raccoons. The finish of the exterior wood siding and trim will be linseed oil. A light coating of linseed oil will rejuvenate the cedar, which is naturally oil-infused wood.

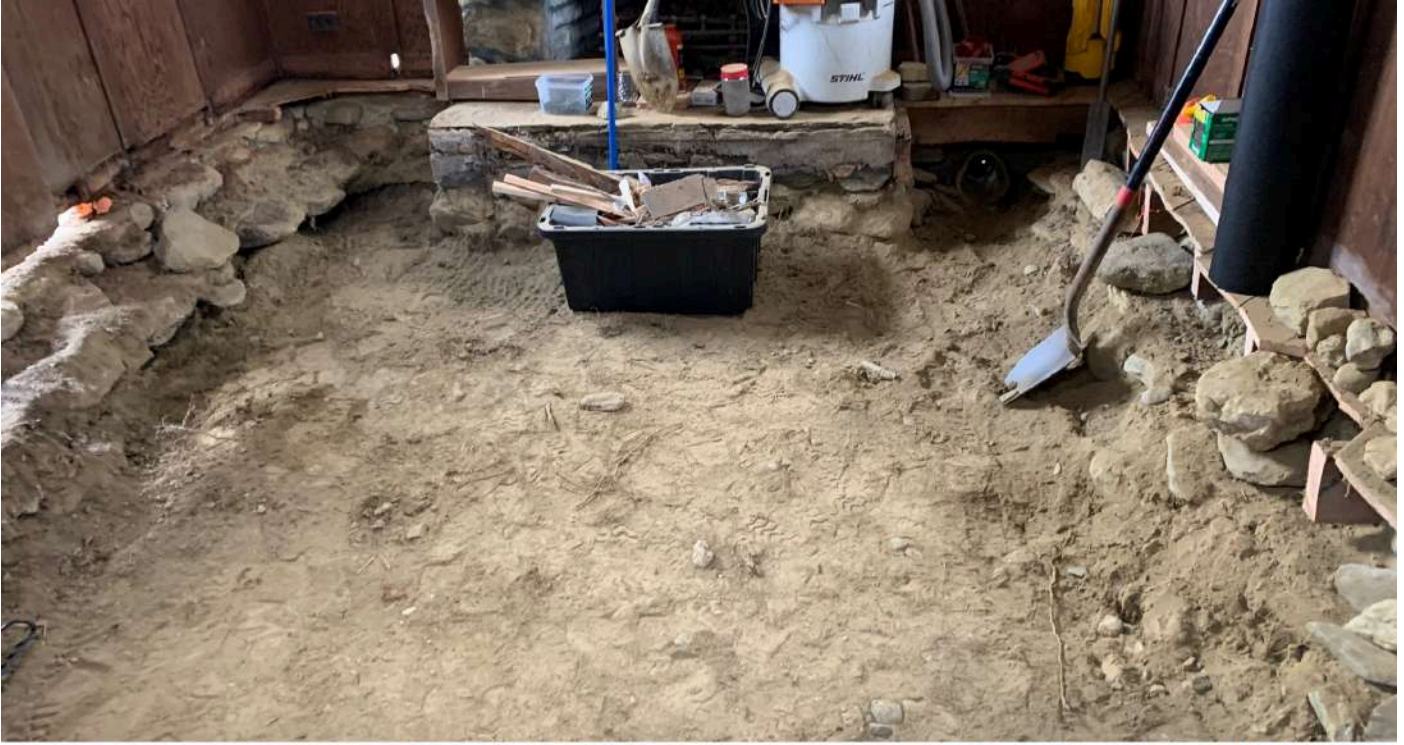
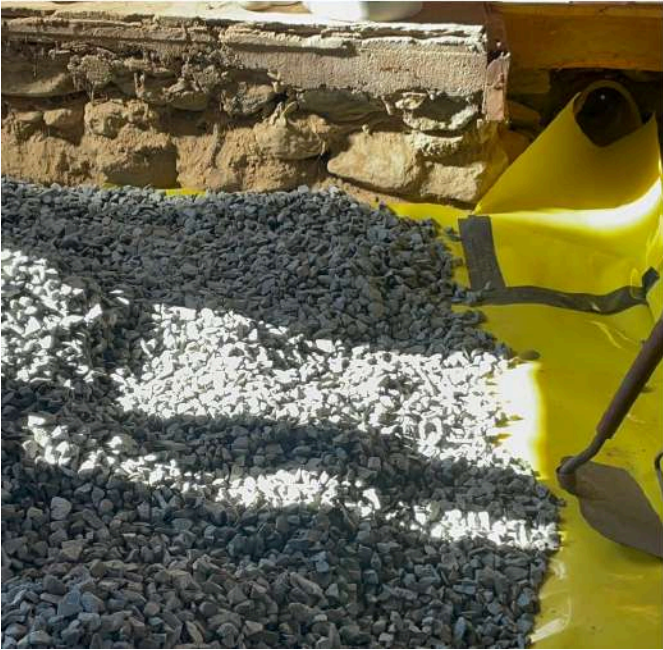
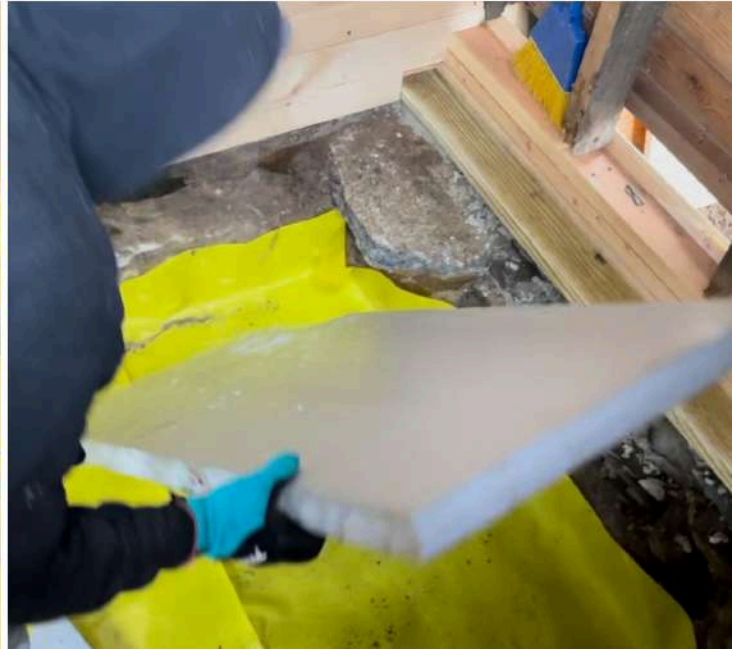
### WRITING CABIN - SOIL, VAPOR BARRIER, STONE, FOAM INSULATION UNDER FLOOR JOISTS

## Change Order for digging soil from below the cabin and replacing with stone

The grade has risen since construction (circa 1926) due to the foliage cycle of its wooded site. The grade has been lowered and sloped away to increase the distance up to the wood siding. Additional exterior site work was needed to bring the grade down in order to create a ventilation space under the floor joists. This includes additional structural work to reframe walls with rotted studs; replacing rotted floor joists; rebuilding the bathroom foundation; and modifying the rest of the foundation in order to accept the floor joists.

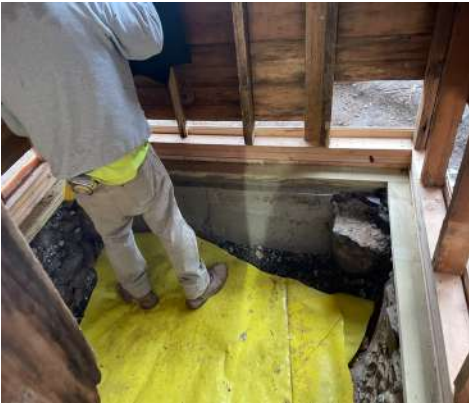
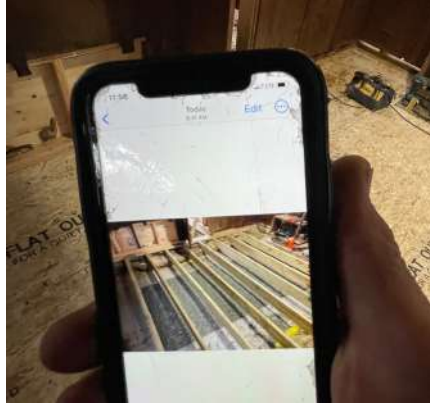
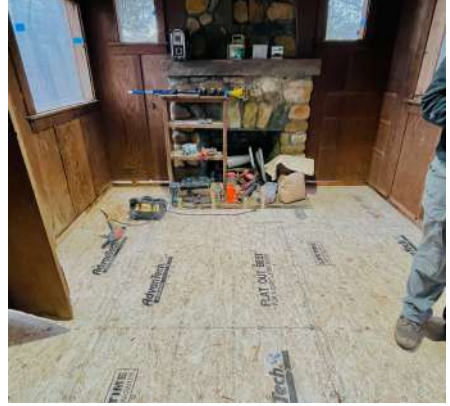
**Additional structural work to replace rotted floor joists; sub-floor to support exterior structure**
